Lake Calhoun Refectory

Facilities Assessment

3000 E. Calhoun
Parkway

November 16, 2016

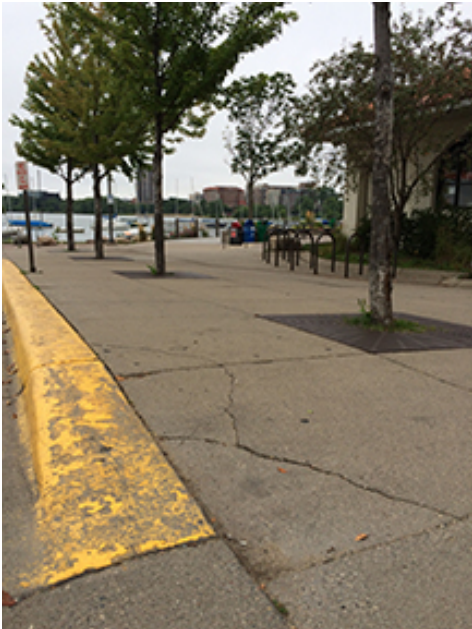
- Customer drop-off is located on the south side of the building, and is shared with sailing school drop-off and pick-up, boat launching, as well as trash collection and delivery trucks for the building vendor. There is heaving and cracking of the concrete at the curb cut in this area and is likely due to the weight of trash and delivery truck traffic. Freeze/thaw cycles may cause continued damage over time and allow moisture intrusion.
Recommendation: Provide a new designated trash collection and delivery area designed to handle the load of heavy equipment.

Cracking at drop-off.

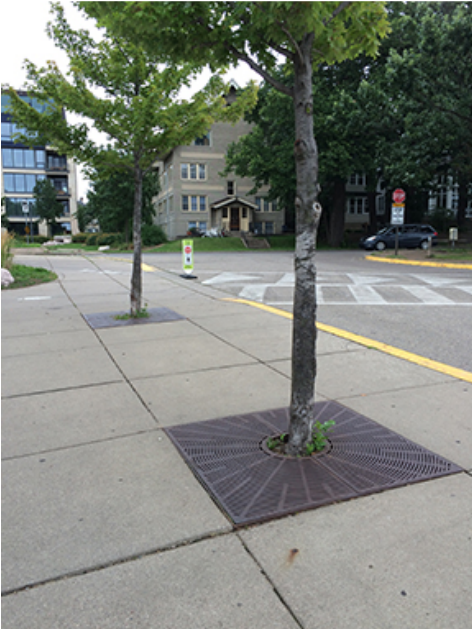
Shared drop-off.

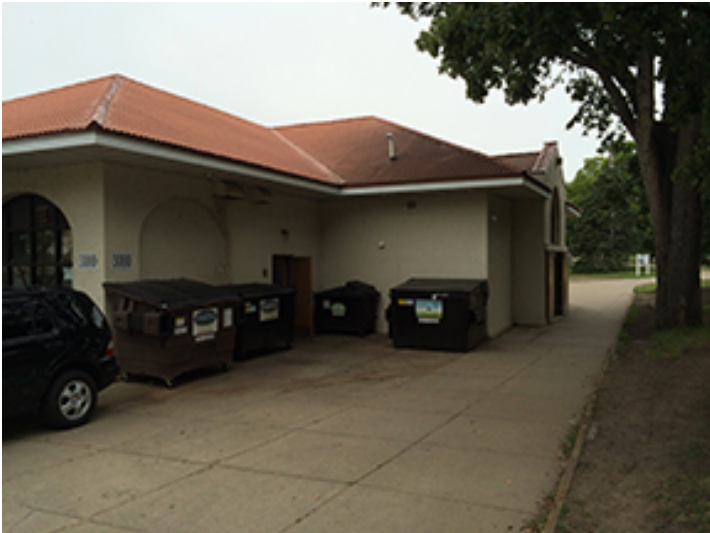
- The trash containers are in an open area on the southeast corner of the building and are directly adjacent to the pedestrian path, and deliveries must be carried or wheeled to the back door along the same pathway designated for pedestrian traffic moving through the site.
Recommendation: Re-route the pedestrian pathway away from the back of the building, and provide employee and delivery-only access at the rear building entry.

Shared pedestrian pathway and trash area.

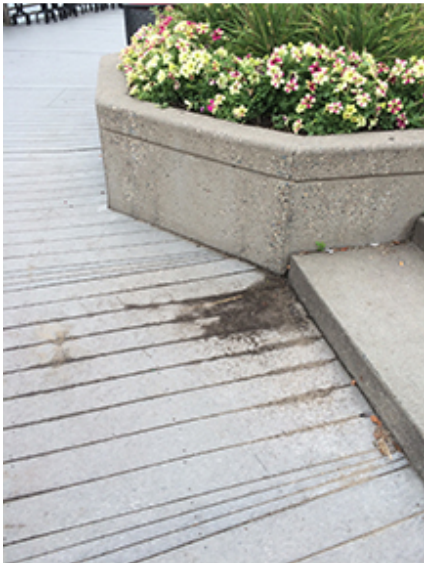
- The composite decking material at the plaza is warped in some areas.
Recommendation: Replace affected boards to match surrounding material.
- There is a general lack of shade and a prevalent exposure to the elements at most of the seating on the plaza.
Recommendation: Provide additional shade in the form of canopied shade structures and/or natural shading via plantings and topiaries.

Warping composite deck.

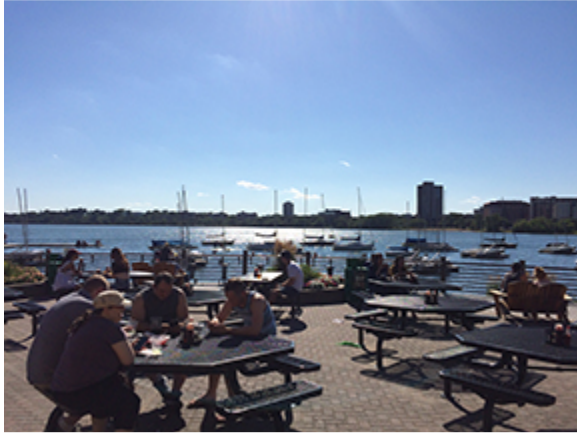
Lack of shade.

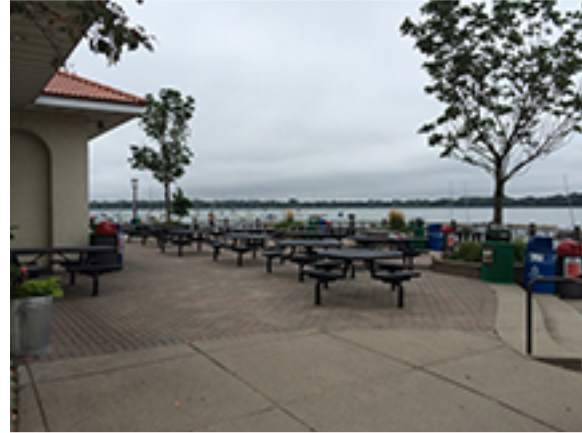
- The primary existing trees at the plaza facing the lake are not thriving, likely due to initial planting conditions as well as their existence in raised concrete planters which do not allow for optimal tree growth and survival. This is likely a contribution to the lack of shade or dappled light at the plaza.
Recommendation: When the terrace is redone, a Silva Cell sub-structure should be put in place with a loamy soil mix conducive to optimal tree growth and infiltration. This system then acts as the structural base for any hard surface paving placed on top of it, while at the same time allowing tree roots optimal growth opportunities. This system also performs as a stormwater treatment filtering bmp – which is also of benefit due to the proximity to the lakefront. It can act as an “underground rain garden” and in can be design to contain up to a 2” rainfall event.

Main trees at plaza.

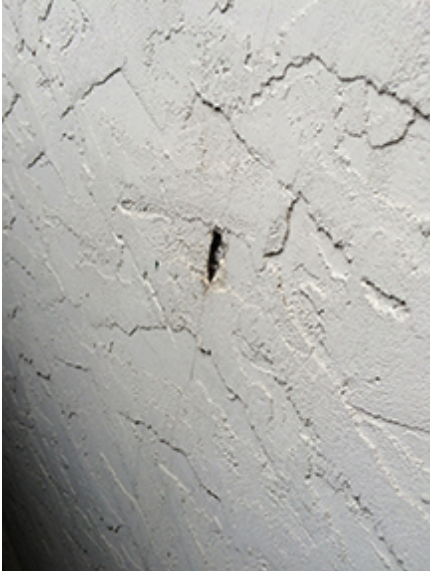
- Some cracking and damage is evident at the trash area where dumpsters have been bumped into the walls, providing areas for water intrusion into the wall assembly.
Recommendation: Damage to the wall finish should be patched, textured and painted to match existing. Bollards placed at key locations to prevent rolling of dumpsters into the building face would prevent further damage.

Damage to Stucco Finish.

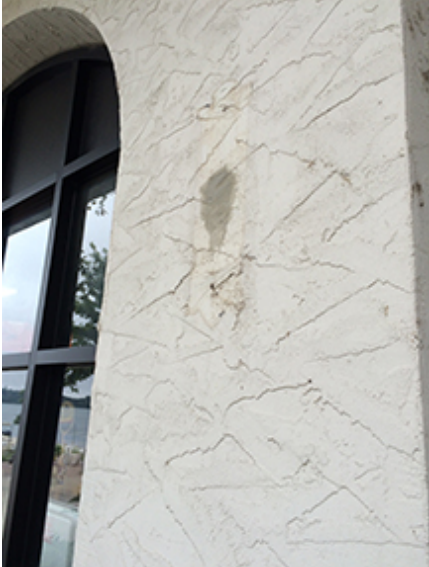
- There are four (4) locations on the building exterior where light fixtures have been removed, and the remaining holes and wall finish have not been repaired, providing areas for water intrusion into the wall assembly.
Recommendation: Holes in stucco and unfinished areas can be patched and painted to match existing finish color and texture.

Area at removed fixtures.

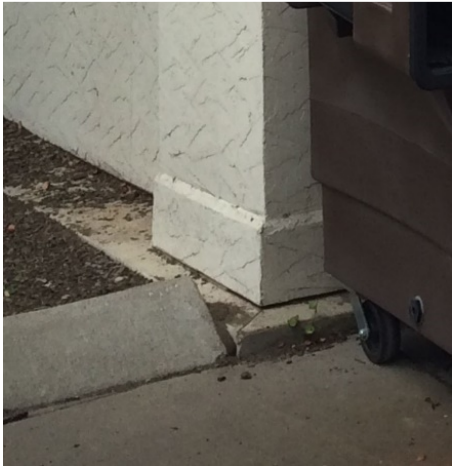
- The base condition of the exterior stucco walls at the existing stucco plinth appears to have a mortared joint, which shows failure and in most locations is cracked, loose and/or altogether missing.
Recommendation: Install backer rod and silicone soft joint at base of stucco walls.

Mortar joint at stucco base.

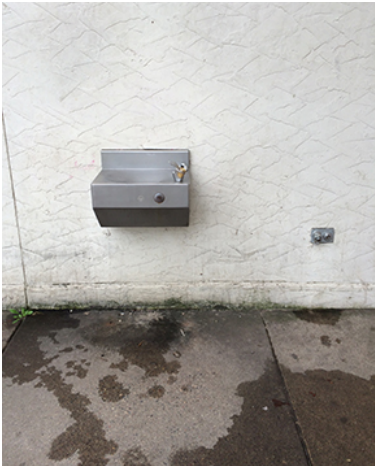
Wall finish at fountain.

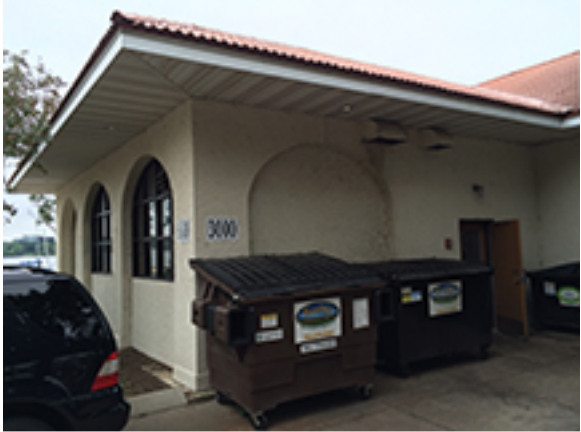
- The existing grease hoods discharge through a sidewall exhaust at the trash area. This configuration does not meet current code, and the downturn in the exhaust leaves dirt and grease on the exterior wall surface.
Recommendation: Upgrade the kitchen exhaust system and associated ductwork to a code-compliant system. Refer to the mechanical portion of this report for more detail.

Grease hoods at exterior wall.

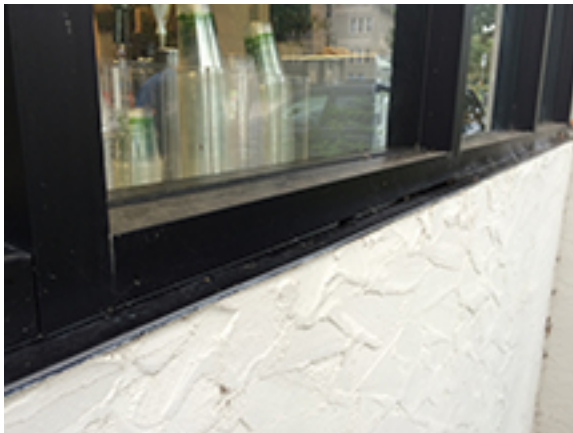
- The flashing detail at the windows does not have positive slope for drainage, rather it slopes back toward the wall openings. No sealant was observed at one of the window frames.
Recommendation: Sill flashing at all windows should be replaced to have positive slope, and ensure proper waterproofing and sealant at perimeter of window openings.

Water collecting at sill flashing.

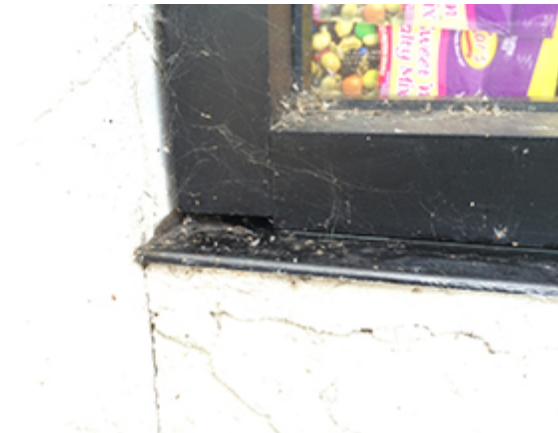
No sealant at frame.

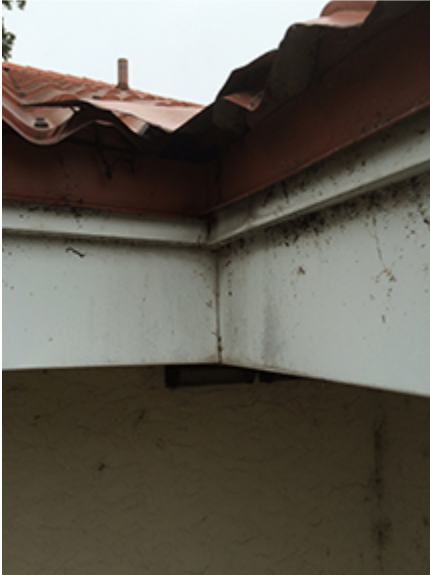
- The roofing and soffit panels appear to be of recent age, and are a metal faux clay tile system. However, about 50% of the end spacers that close the gaps at the eaves were observed to be loose, dislodged or missing. The paint at the raw edge of the metal tiles is also wearing off.
Recommendation: All spacers at roof eaves should be replaced and secured to protect against wind-driven rain and animals. Re-finish or place trim at the raw tile edge.
- Roofing filler pieces at the ridge cap are missing in several places, and a bird or animal nest was observed at that location.

Roof tile at eave.

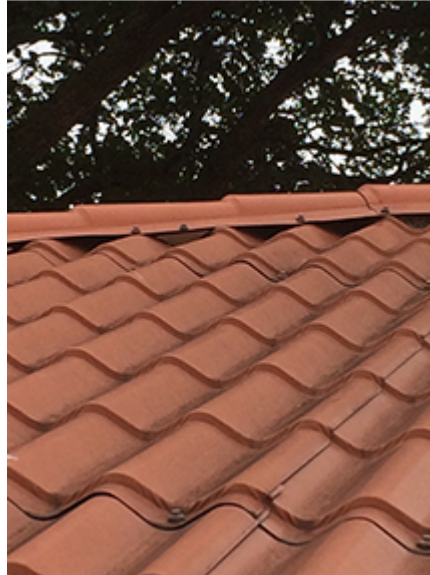
Ridge cap.

Recommendation: Infill pieces should be replaced along the length of the ridge cap and secured.

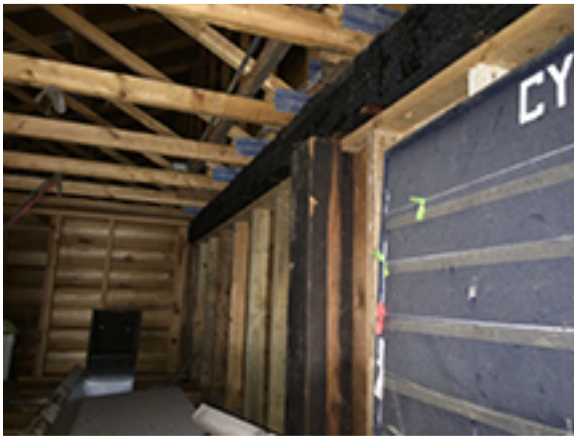
At least a portion of the building's timber structure has been exposed to at least one fire. Charring of varying degrees is visible on roof framing, beam and column members. Damage should be assessed by a structural engineer if a professional analysis has not already been done.

Fire damage at roof structure.

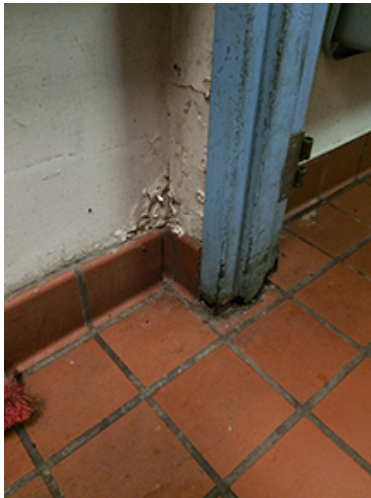
- Interior base of wall conditions is generally poor and much corrosion, material build-up and wear was observed.
Recommendation: Remove and replace flooring and cove base with a code-compliant, resilient material designed to handle the more frequent and heavy duty cleaning typical of today's commercial kitchens.

Bottom of wall.

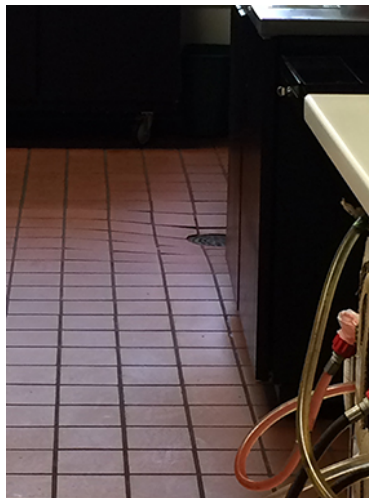
Slope at drain.

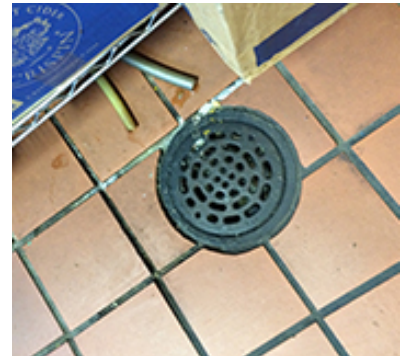
- Floor tile on the interior of the building, including the floor in the open covered areas, is very uneven, cracked in some places, missing grout in some areas, and does not appear to properly slope to existing drains.
Recommendation: Existing quarry tile should be removed and drain locations should be examined against new concept layout and located as appropriate. The topping slab should be re-graded to properly slope to all drains. New flooring for both public and back of house areas should be installed. Maintaining a year-round building temperature of above freezing will interrupt the freeze-thaw cycle, which will help avoid cracking of new material.

Eroded grout at drain.

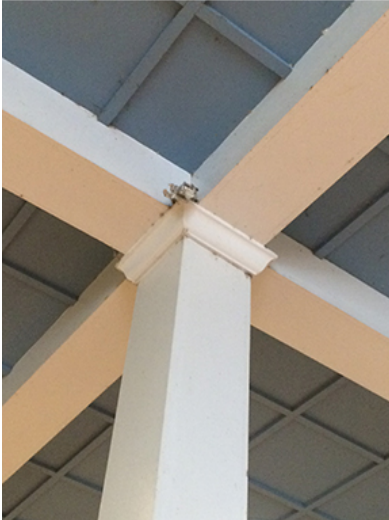
The ceiling system in public areas and former breezeway is painted plywood with surface-applied 1"x2" wood lattice grid. It is in generally good condition, though the typical top of column detail provides areas for bird nesting. Back of house ceilings are painted 1/2" gypsum board on wood framing.

Bird nest at column.

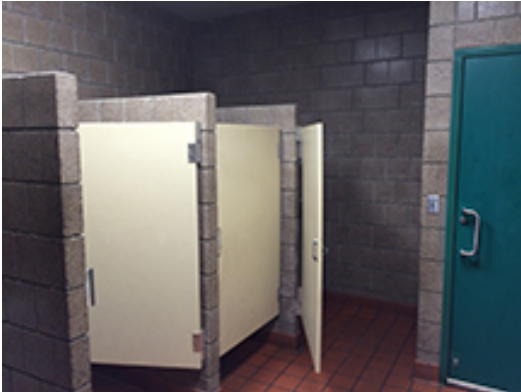
Women's restroom stalls.

Recommendation: Demolish the existing restrooms and provide a new separate, fully accessible restroom facility to accommodate current and anticipated future occupancy and increased program. A family or gender-neutral accommodation should also be considered, for privacy, accessibility, and parents with children of the opposite gender. Updated water- and energy-saving technology such as high efficiency hand dryers and low flow fixtures could be incorporated. If restroom relocation cannot be achieved in the near term, the existing restrooms would need to be gutted and remodeled to meet code requirements for accessible and ambulatory stalls as well as lavatory, fixture and accessory heights, controls and clearances. This would result in the loss of one urinal.

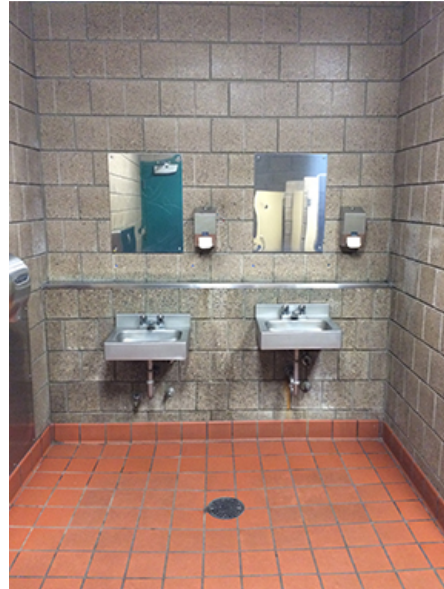
Sinks in Women's restroom.

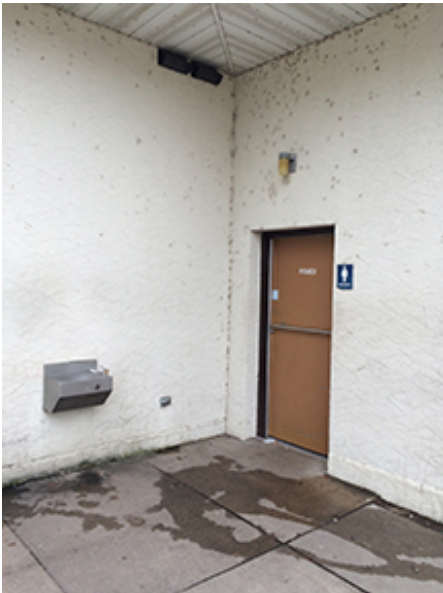
- Current public restroom signage and design does not meet current Minnesota Accessibility Code requirements.

Restroom signage.

Recommendation: Replace/add code-compliant signage at all restrooms.

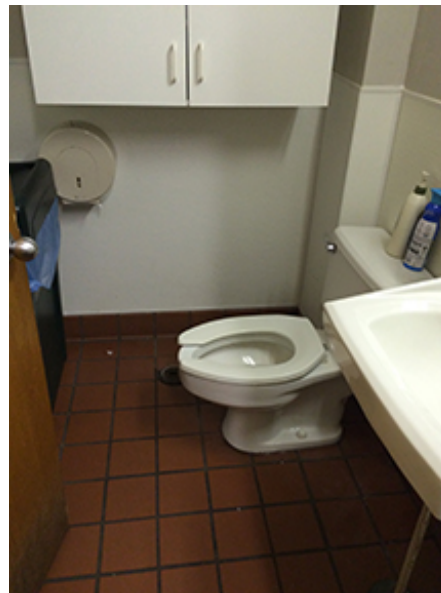
Employee restroom.

Recommendation: Expand and renovate existing employee restroom to meet Accessibility Code requirements, and provide an alcove at the entry to shield it from dishwashing area.

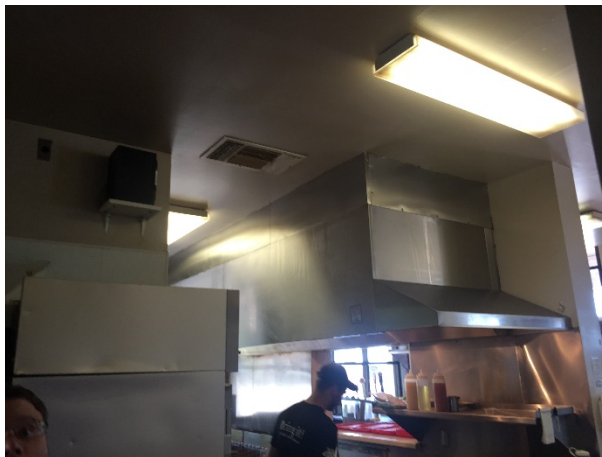
- The associated kitchen hood is exhausted by a utility set exhaust fan located in the attic space. Welded ductwork transports the grease-laden air from the hood to the fan and from the fan to the discharge. The ductwork likely does not meet the distance requirement from combustible materials. Discharge is through the sidewall with bird screened downturned elbows under the eave. This installation does not meet current code. This system was installed in the late 1980's and is in poor condition. Ductwork clearance from combustibles is questionable. It is deficient with respect to current code requirements. No air is supplied to the office.
Recommendation: Replace the entire kitchen HVAC system with a code compliant system

Kitchen hoods over the cooking appliances.

The hoods are served by exhaust fans located above the ceiling in the attic space. The fans are original to the 1988 remodel.

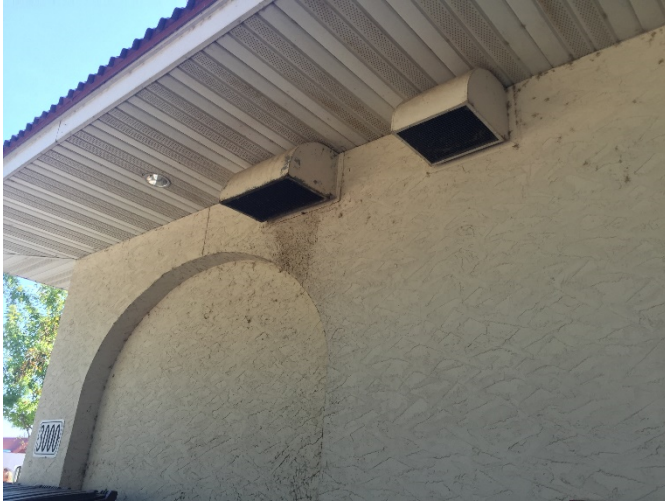
Kitchen hood exhaust termination.

These do not meet current code requirements for discharge per the Minnesota Mechanical Code and NFPA 96.

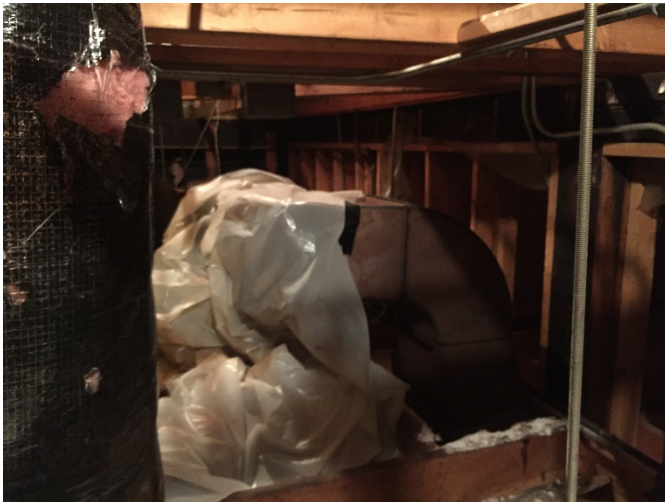
Welded kitchen hood exhaust ductwork.

Further investigation is required to confirm if the duct and routing meet the required clearances from combustible construction.

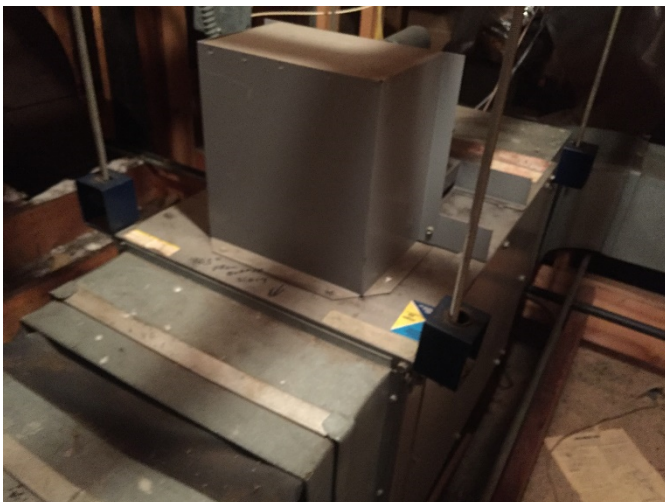
Inline exhaust fan serving the facility.

Original to the remodel in 1988.

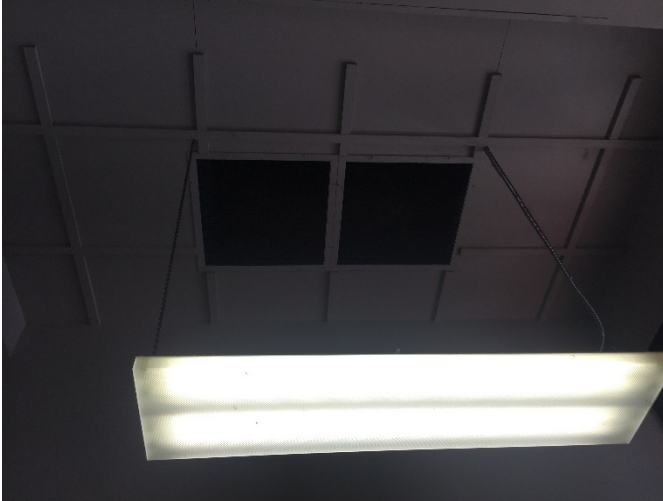
Makeup air intake grilles.

These were previously outside the envelope of the facility, but were enclosed during a recent remodel. The makeup air unit they supply is not operational. The kitchen exhaust makeup air is supplied through open windows and doors and leakage.

- The kitchen is served by operable windows and makeup air units located in the attic space. Controls for the systems were observed on the wall, but it was noted that they were not operational. Intake is ceiling mounted and distribution is through uninsulated steel ductwork and discharged through ceiling mounted directional diffusers. During a more recent front of house remodel, the outside air intake location was enclosed so it now resides inside the building envelope.
Recommendation: Determine if enough fresh air is provided through existing openings when building is operational. If not, a new code-compliant make-up air system should be installed.

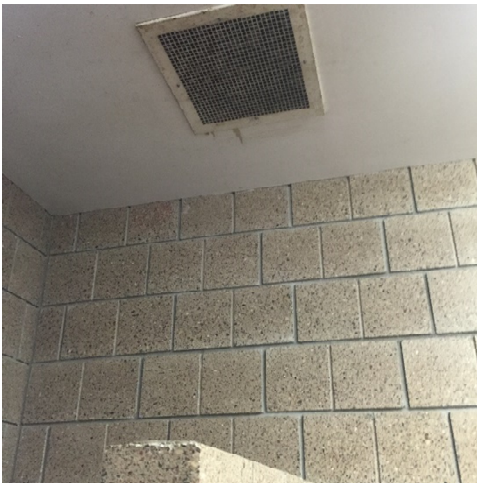
- The equipment was installed in the late 1980's and is in poor condition. The fans are well past their useful lives.
Recommendation: Replace restroom exhaust system.

Restroom exhaust grille.

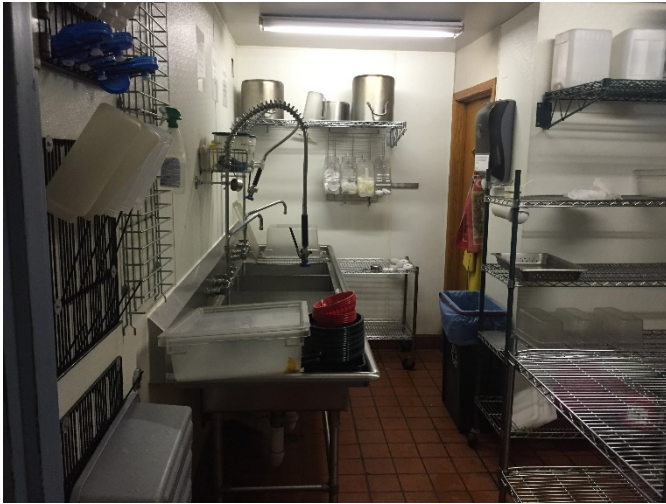
- The storage room is also used as a dishwashing and mechanical room. No heating, cooling or ventilation was observed. No dedicated dish exhaust was observed. This space does not meet code requirements to be used as a dishwashing area. It does not have a mechanical system, ventilation or exhaust system.
Recommendation: Provide a new code-compliant system including exhaust.

Dishwashing area.

No ventilation observed.

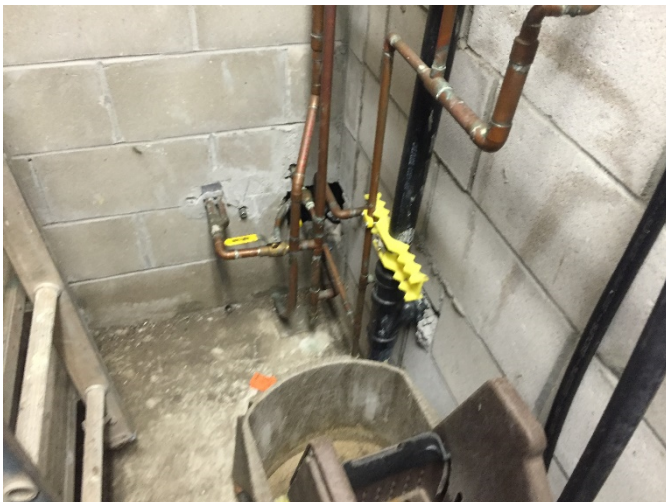
Domestic water and assumed irrigation piping.

A backflow preventer is installed upstream on the assumed irrigation pipe. Valving on the backflow preventer is shut off so the piping is assumed not to be operational.

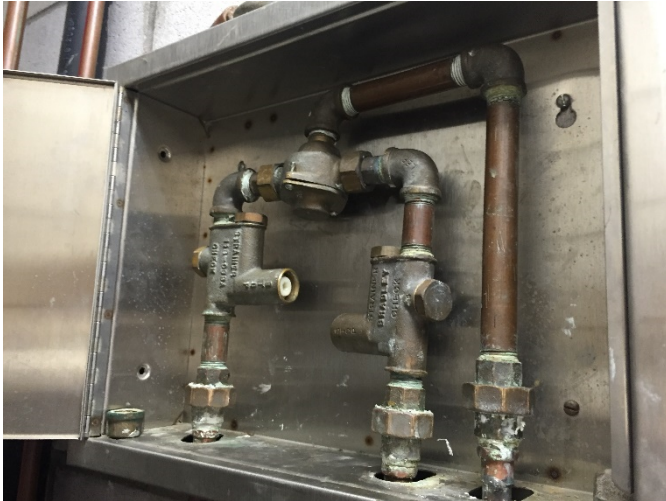
Thermostatic mixing valve serving the lavatories.

Further investigation needs to occur to determine if the valve meets ASSE 1070 requirements for use on public lavatories.

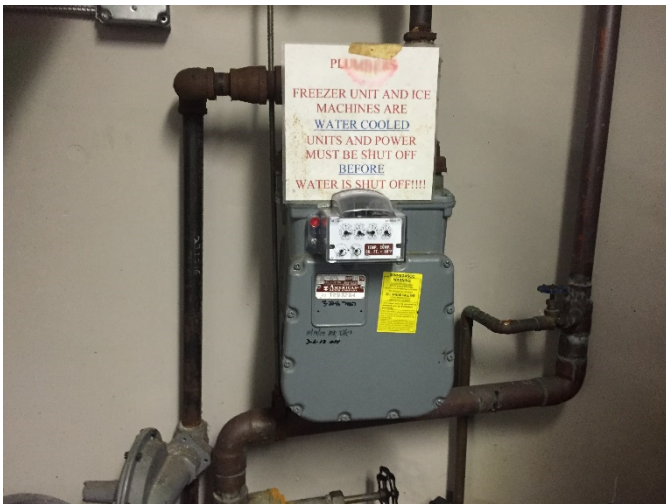
Gas meter.

2# gas is available in the facility and regulated at the meter. The sign placed on the meter mentions a water cooled freezer unit. Further investigation needs to occur to determine if this system meets the current energy code if reused in the future design of the facility and will be allowed to be reinstalled.

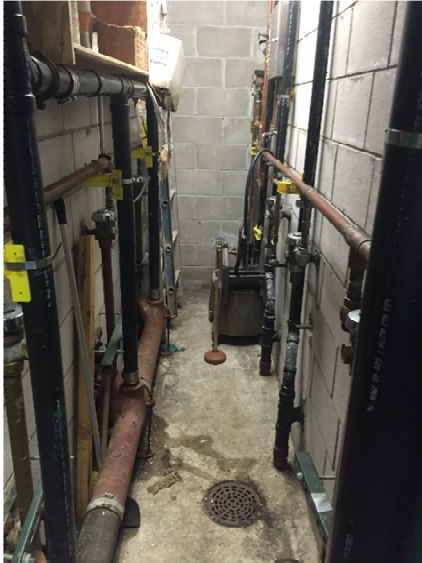
Restroom chase water and sanitary waste piping.

Domestic water is uninsulated copper piping with soldered joints. Sanitary waste is cast iron. Vent piping is ABS. A leak was observed on one of the women's water closets.

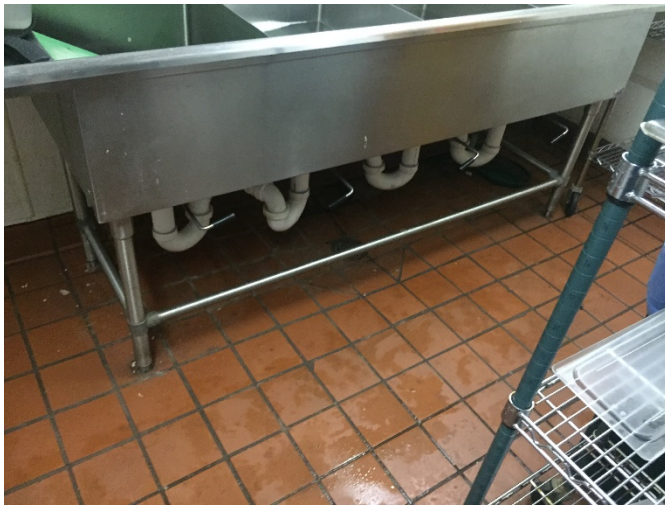
Three compartment sink used for dishwashing.

No grease interceptor was observed.

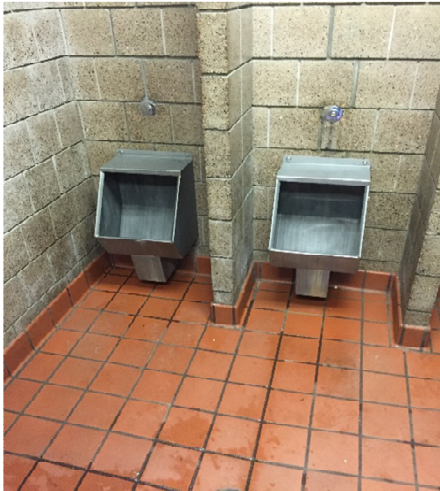
Men's public restroom urinals.

Stainless steel construction with manual pushbutton operation.

Replace plumbing fixtures with new low flow fixtures. Modify system as required for service of fixtures in new facility layout.

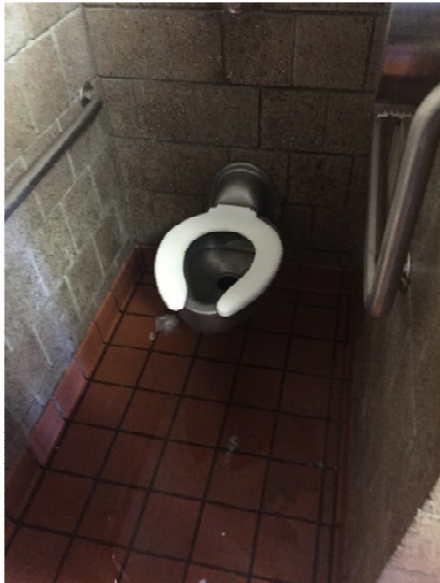
Men's public restroom water closet.

Stainless steel construction with manual pushbutton operation.
Does not meet ADA requirements for wheel chair access.

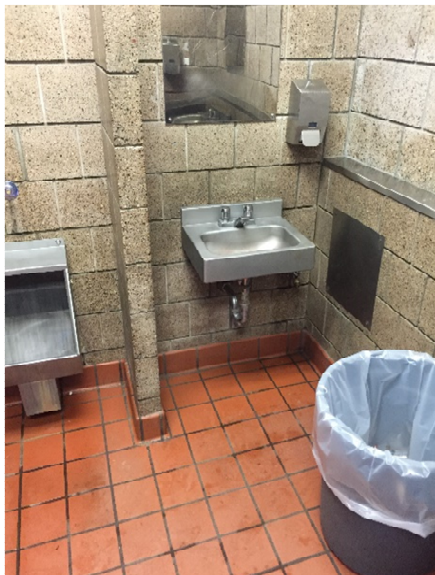
Men's public restroom lavatory.

Stainless steel construction with manual pushbutton operation.
Unlikely meets ADA requirements for mounting height.

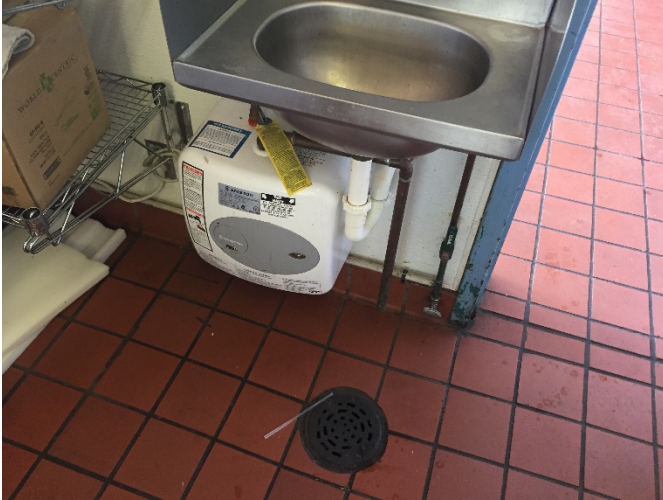
Handwash sink and instantaneous water heater located in the front of house area.

The TP valve is piped to near the floor below the sink. Discharge could scald someone standing at the sink.

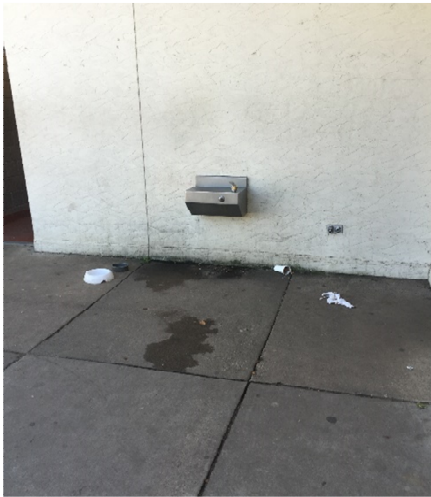
Public drinking fountain located on the back side of the facility constructed of high abuse stainless steel.

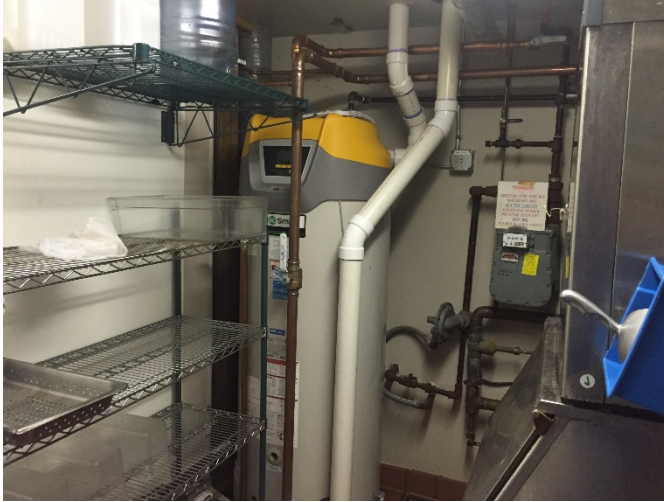
AO Smith cyclone, high efficiency water heater.

Model BTH 150-200. Natural gas fired with 178.18 gallons of recovery per hour. 100 gallon tank.

The heater is only one year old and in good condition. Domestic hot water distribution piping is not insulated. Domestic cold water distribution piping is also not insulated.

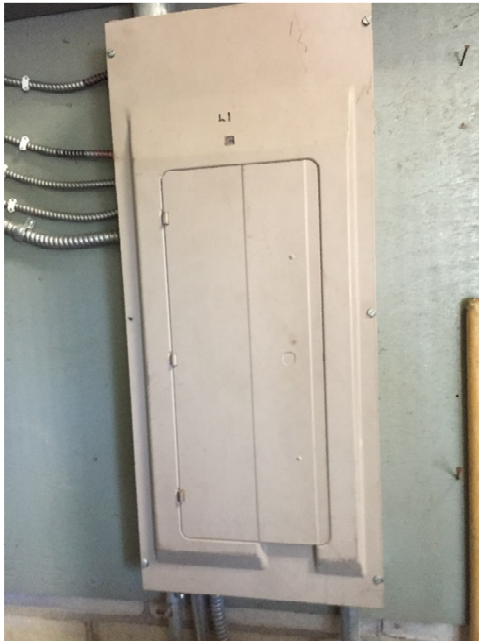
(2) 200A panels are in fair condition.

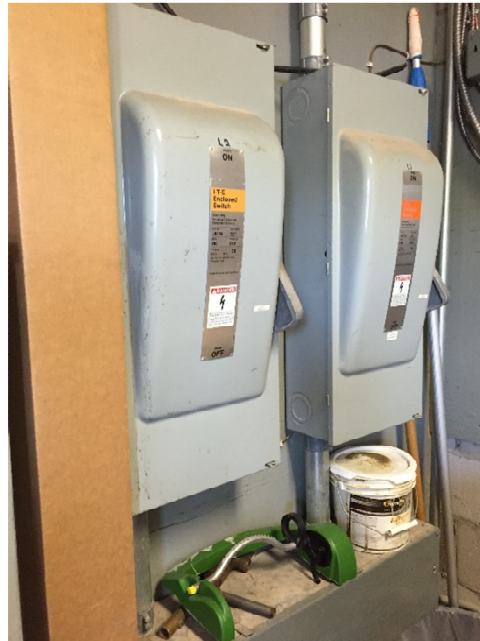
(2) 200A fused disconnects.

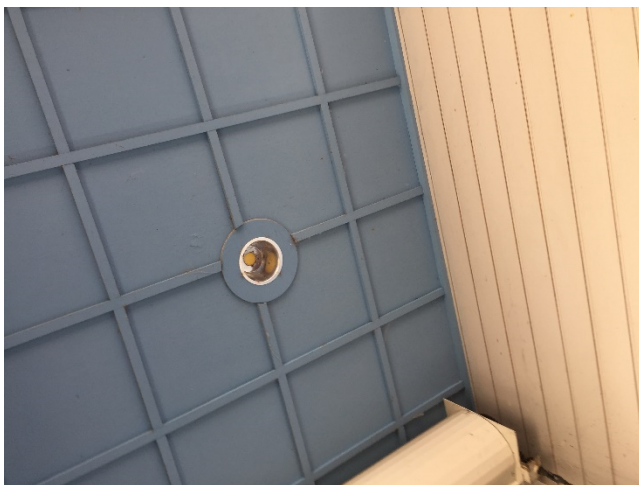
LED lighting at canopy.

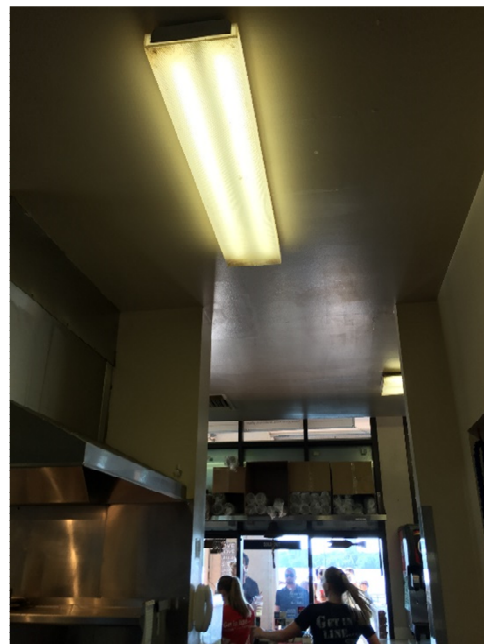
- The existing interior lighting is linear fluorescent wraparound lighting. Exterior down lighting (and canopy area) are typical 6" and 8" recessed LED can lights. Newer (2012) Lighting Control System Exists for ON/OFF, Time of Day, and scheduling functionality. *Recommendation:* Interior lighting levels are fairly consistent where some areas could be increased for better illumination for utilization of space with possible upgrade to LED lighting. Replacing existing interior lighting with LED lighting would provide maintenance and energy savings for the Owner. With a variety of LED fixtures, retrofits, or lamps available, the Owner has several options to cost saving benefits from the LED technology.

Interior fluorescent lighting.

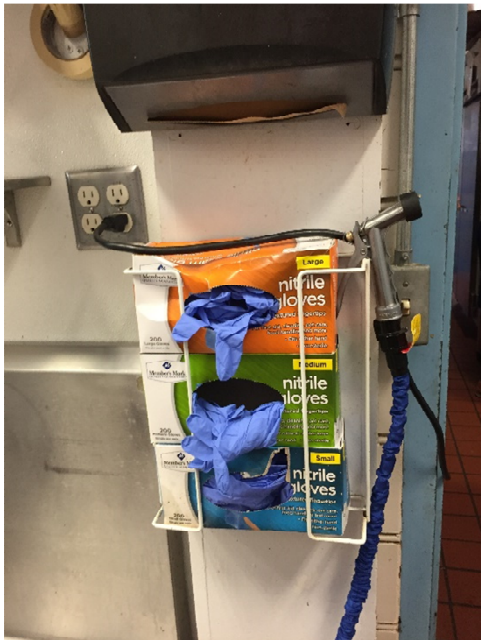
- Some electrical devices are located in close proximity to wet locations.
Recommendation: In wet areas, provide Ground Fault Interrupting Circuit devices (Breakers or receptacles). In wash down kitchen areas, provide weather proof devices.
- Some electrical devices are located in areas that could be accessible to children.
Recommendation: Tamper-resistant devices in areas where children could be present.
- Commercial plug strips were observed at kitchen equipment areas.
Recommendation: Add additional wiring devices and remove commercial plugstrips.

Devices at wet areas.

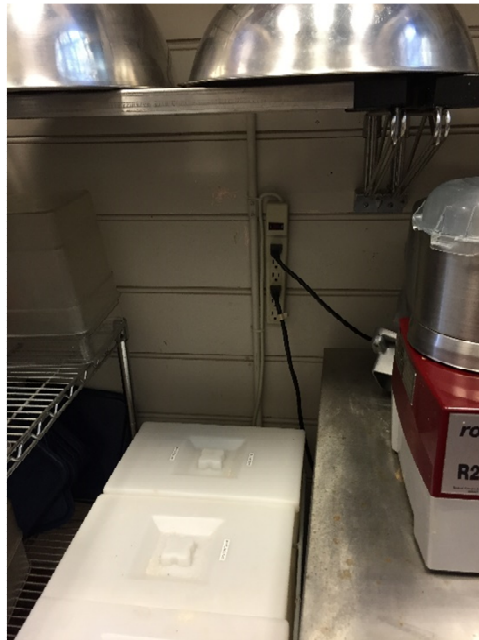
Existing plug strips.
